Key Bank Building Demolition

Air Monitoring Summary

Utah Division of Air Quality

January 9, 2008

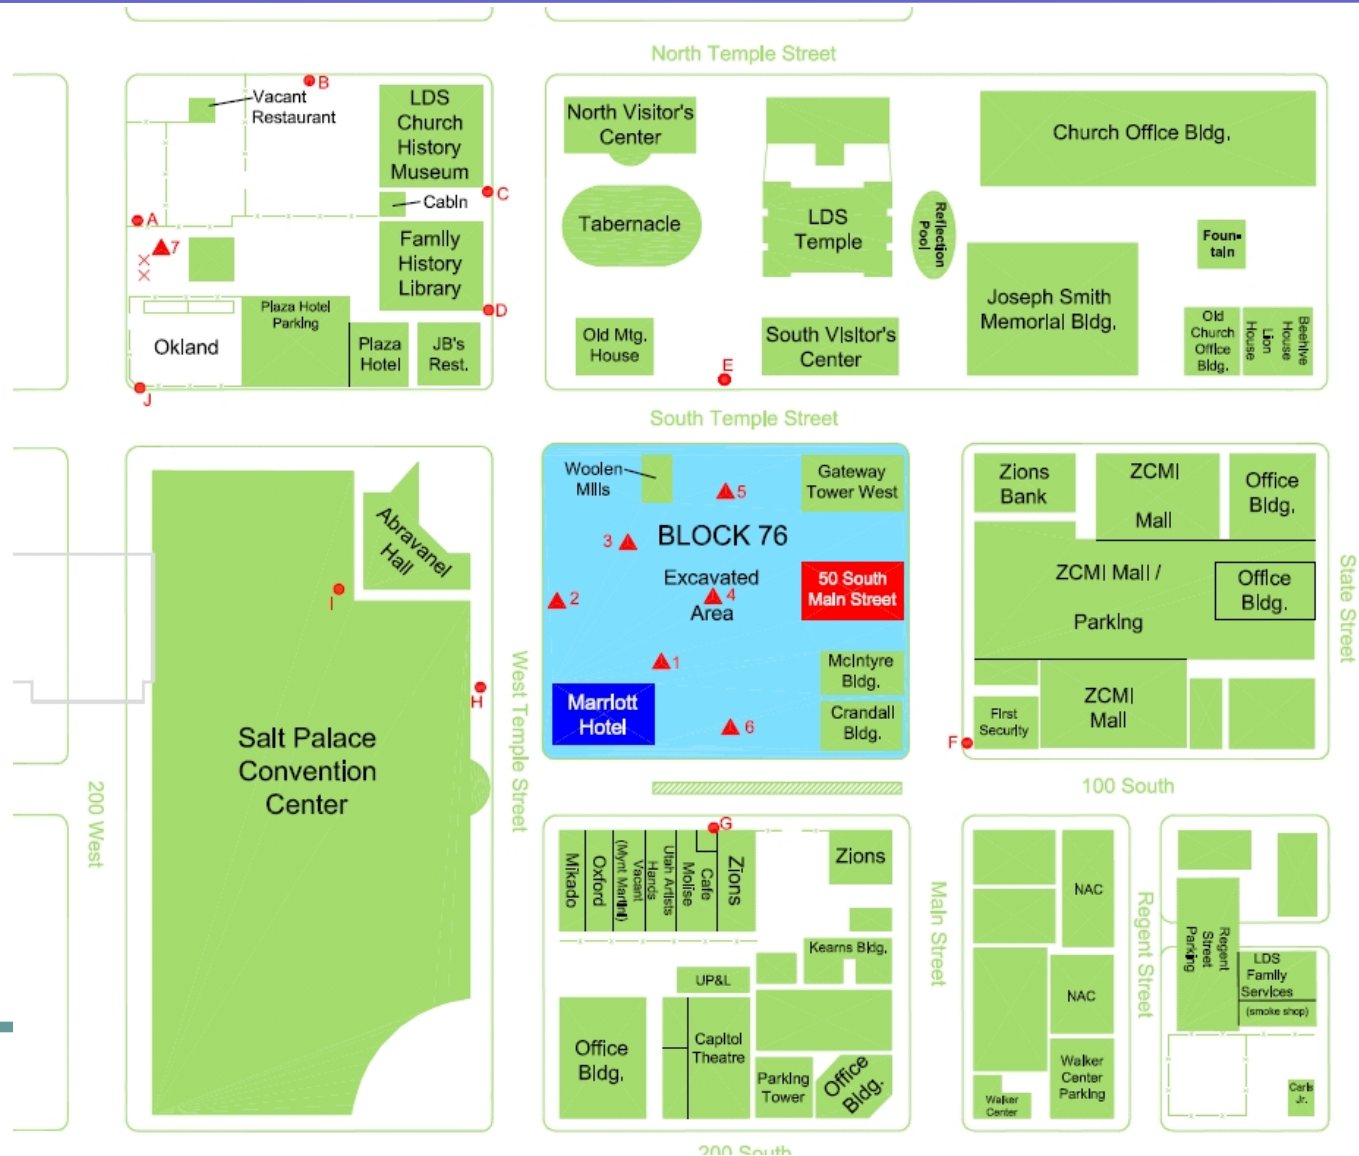
Air Sampling Plan

- Air samplers were set up to operate for 5-days prior to and 5-days after the implosion
- Event sampling was placed down wind from the implosion
- The samplers included TSP, PM₁₀, PM_{2.5}, Lead, Silica and Asbestos

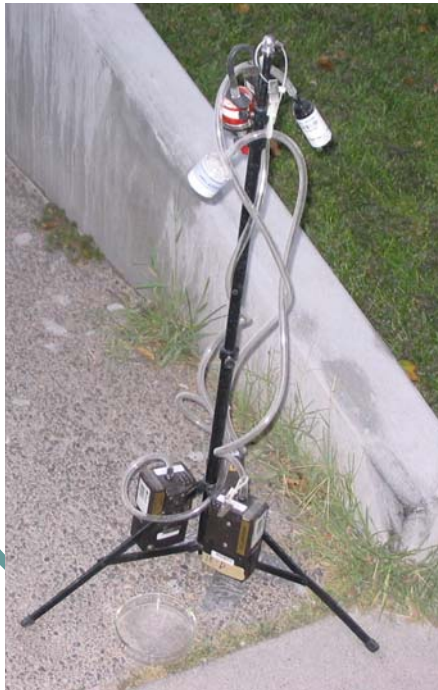
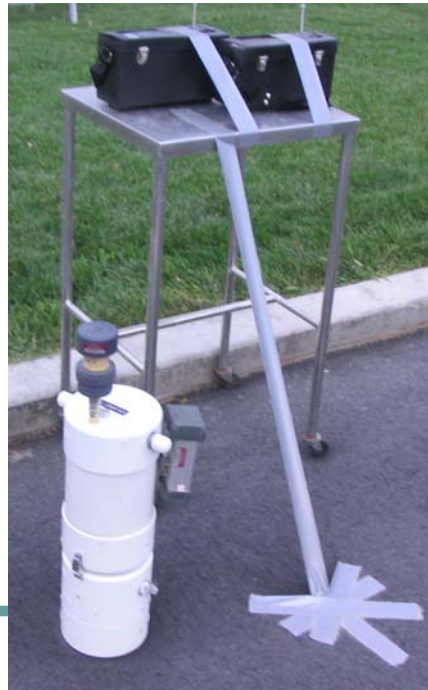
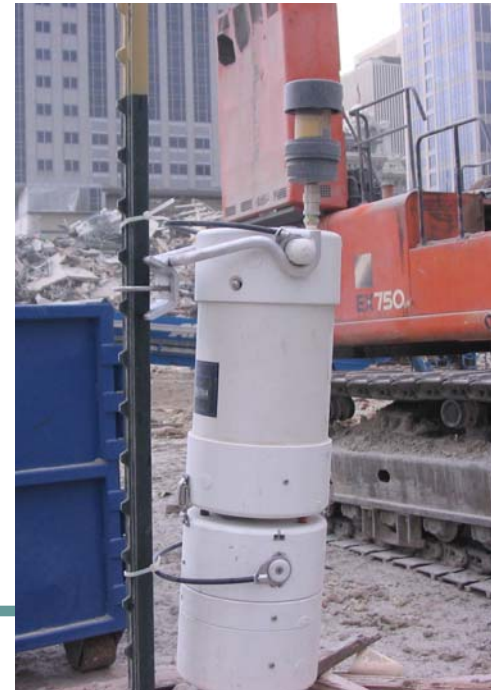
Air Sampling Plan

- Indoor samples were collected in the air handling system of 6 buildings within the declared dust impact zone

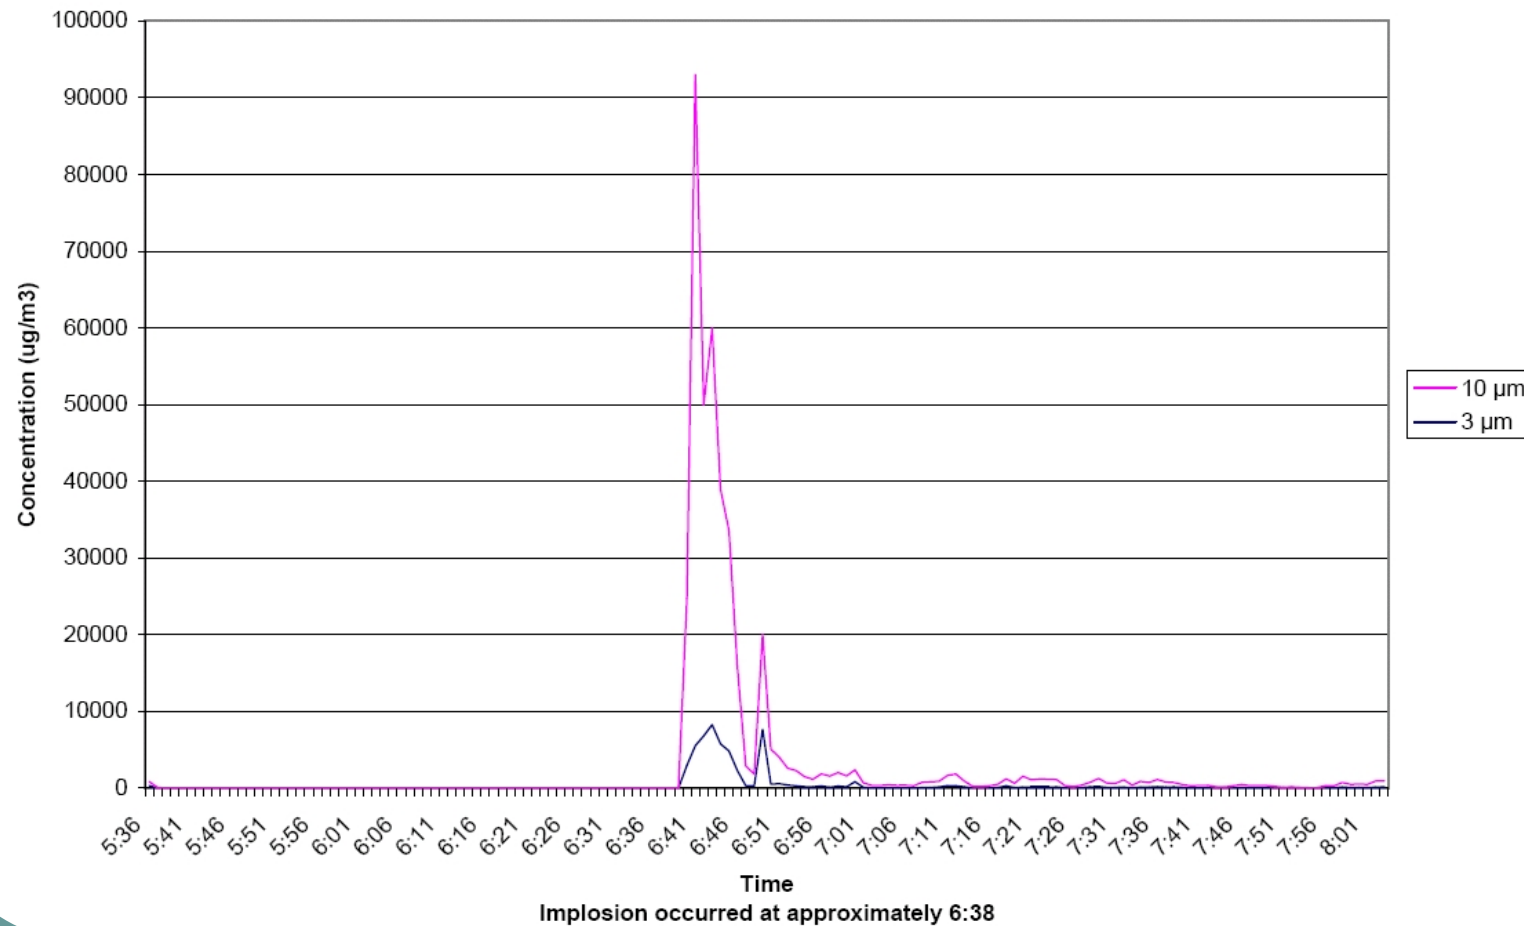
PM10 and PM2.5 Concentrations - Grimm Dust Monitor

- Levels of airborne PM₁₀ and PM_{2.5} exceeded health standards for a short time following the implosion within the dust impact zone
- No hazardous constituent samples were above occupational exposure levels and most samples were below detection limits

- Many near perimeter samples were flagged by the lab due to overloading or loose debris on the filters
- The PM₁₀ four-hour concentration was 685.71ug/m³ at the North-west edge of the dust impact zone
- The PM₁₀ average concentration was 28.81ug/m³ at the NW monitor during the 3-25th hour after the implosion

- The calculated 24-hour average PM₁₀ concentration at the NW edge of the dust impact zone was 138 ug/m³. This value is below the ambient standard of 150 ug/m³
- The Salt Lake PM₁₀ concentrations were 19 ug/m³ at the Hawthorne monitor and 24 ug/m³ at the North Salt Lake monitor on August 18th.

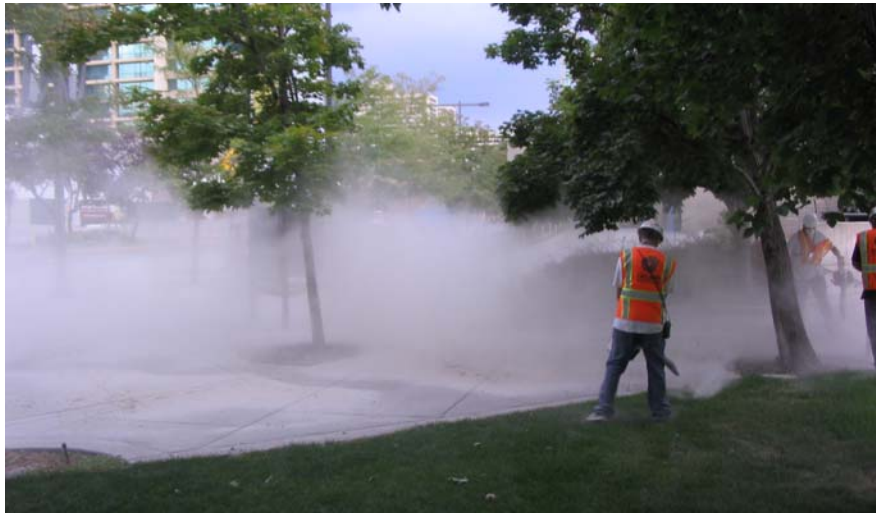
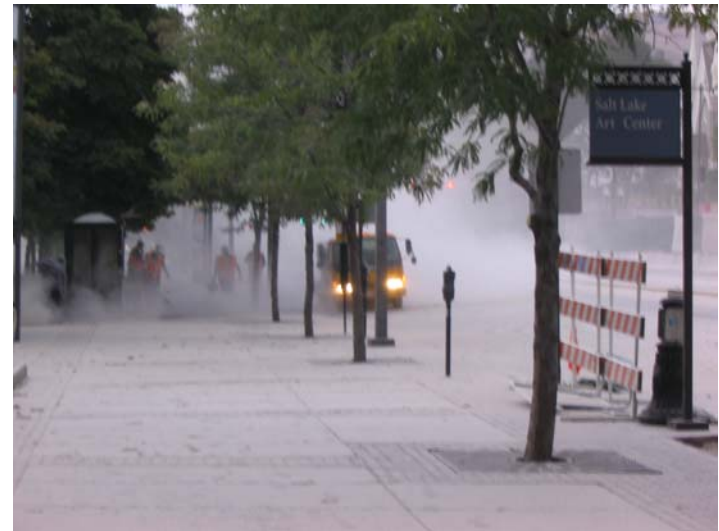
- The modeling evaluation for the variance request predicted an increase of 12 $\mu\text{g}/\text{m}^3$ to the 24-hour average at the edge of the dust impact zone due to the building implosion. The modeling evaluation did not appear to take into consideration the post demolition cleaning activities

Ongoing Cleaning at 8:30AM
